North Coast Regional Water Quality Control Board

INSPECTION MEMO

BoDean Co Inc. Santa Rosa Hot Plant, 1060 Maxwell Drive, Santa Rosa, Sonoma County

March 18, 2021

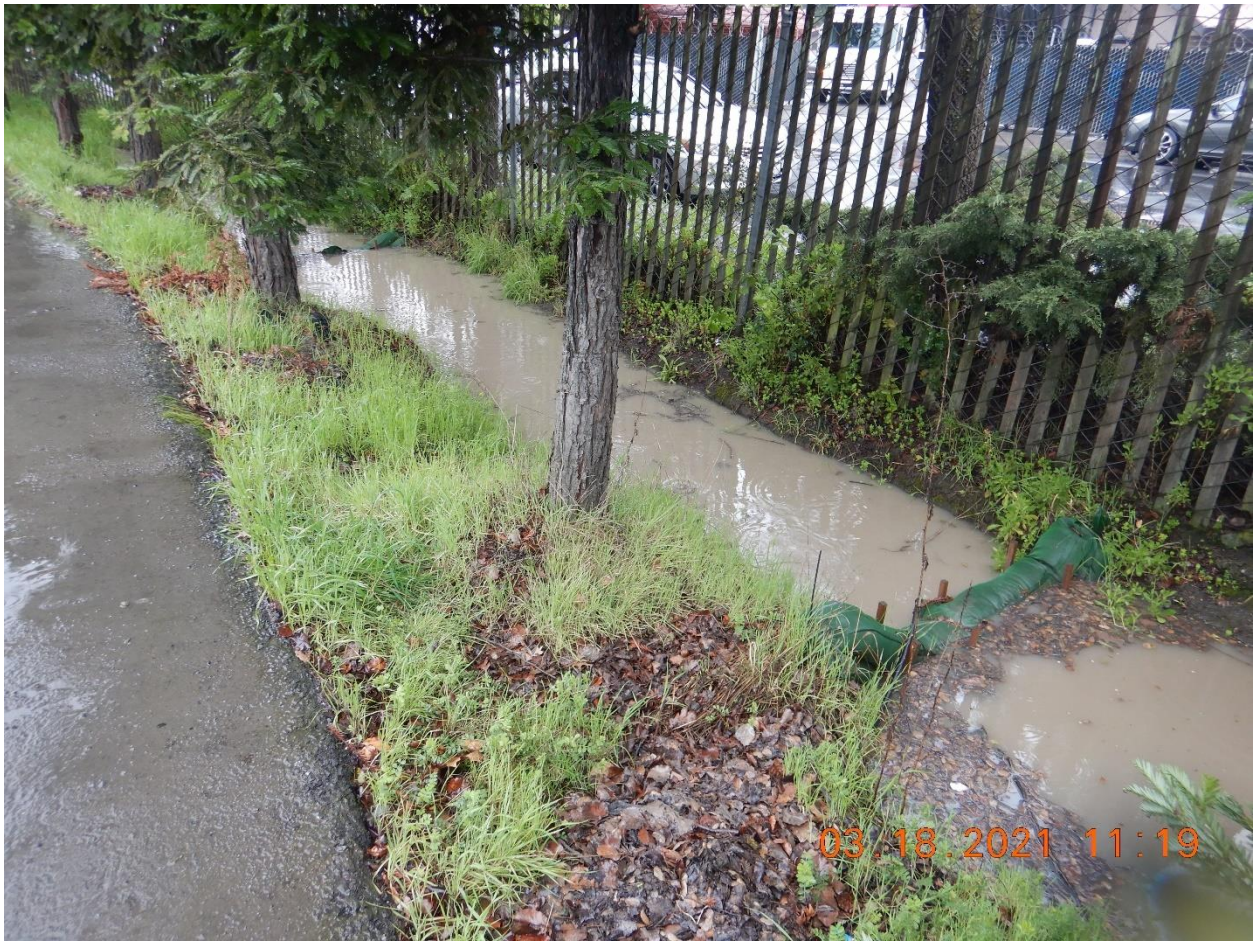
During the inspection, I also observed turbid water discharging into the storm drain drop inlets throughout the Facility. I also observed that all advanced BMPs, including the existing bioswale, settling tanks, and settling pond, were full of turbid water that was overflowing and draining into a drop inlet which is connected to the discharge point via the storm drain system (see attached photos 1, 2, 3, 4, and 6). I also discussed with Facility staff that the existing minimum and advanced BMPs appeared to be inadequate, based on the observed condition of the BMPs and the turbid discharge.

Picture 1- View of the existing bioswale full of turbid water along the southwest corner of the facility (refer to the attached site map). Picture taken by Farzad Kasmaei.

Also, the Industrial General Permit requires the Facility to ensure that the existing advanced BMPs including settling pond, tanks and the bioswale are adequate and appropriately maintained. Since this Facility remains in active operation during QSEs, source control implementation, and adequate minimum and advanced BMPs are critical.

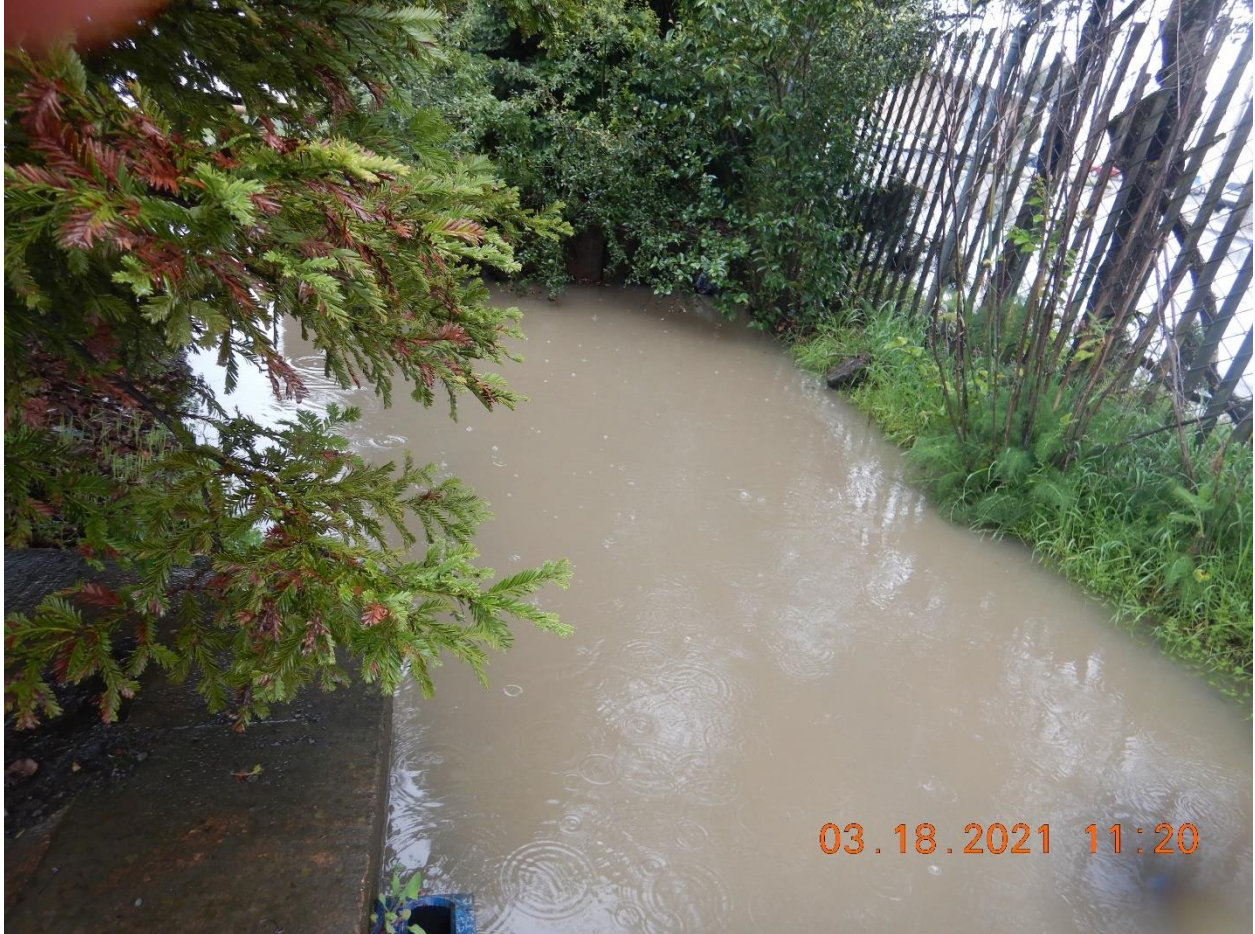
Picture 2- View of the location of a couple of existing settling tanks that were submerged. Picture taken by Farzad Kasmaei.

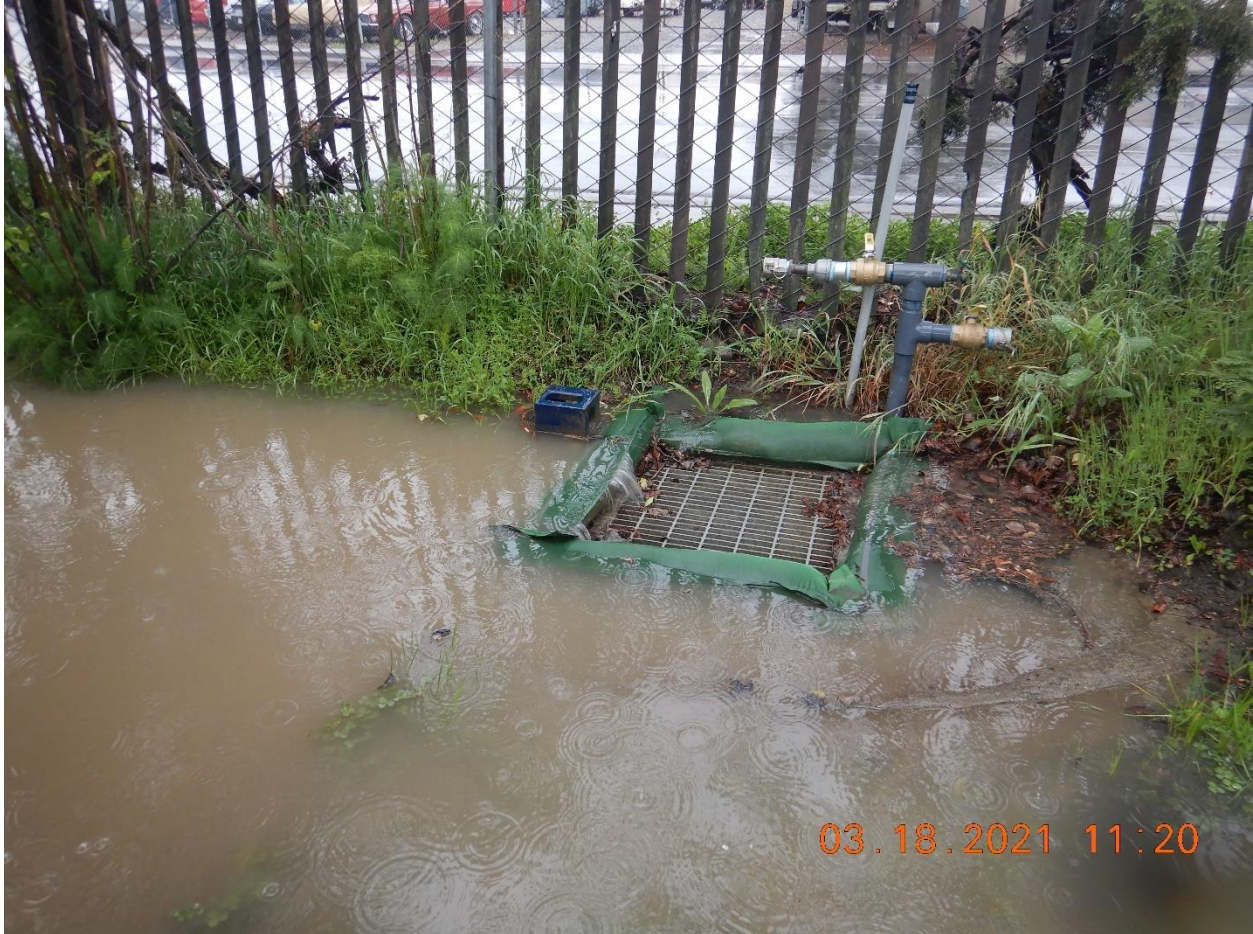
Picture 3- View of the drain inlet No. 11 that receives runoff from the bioswale and the settling tanks once they overflow.

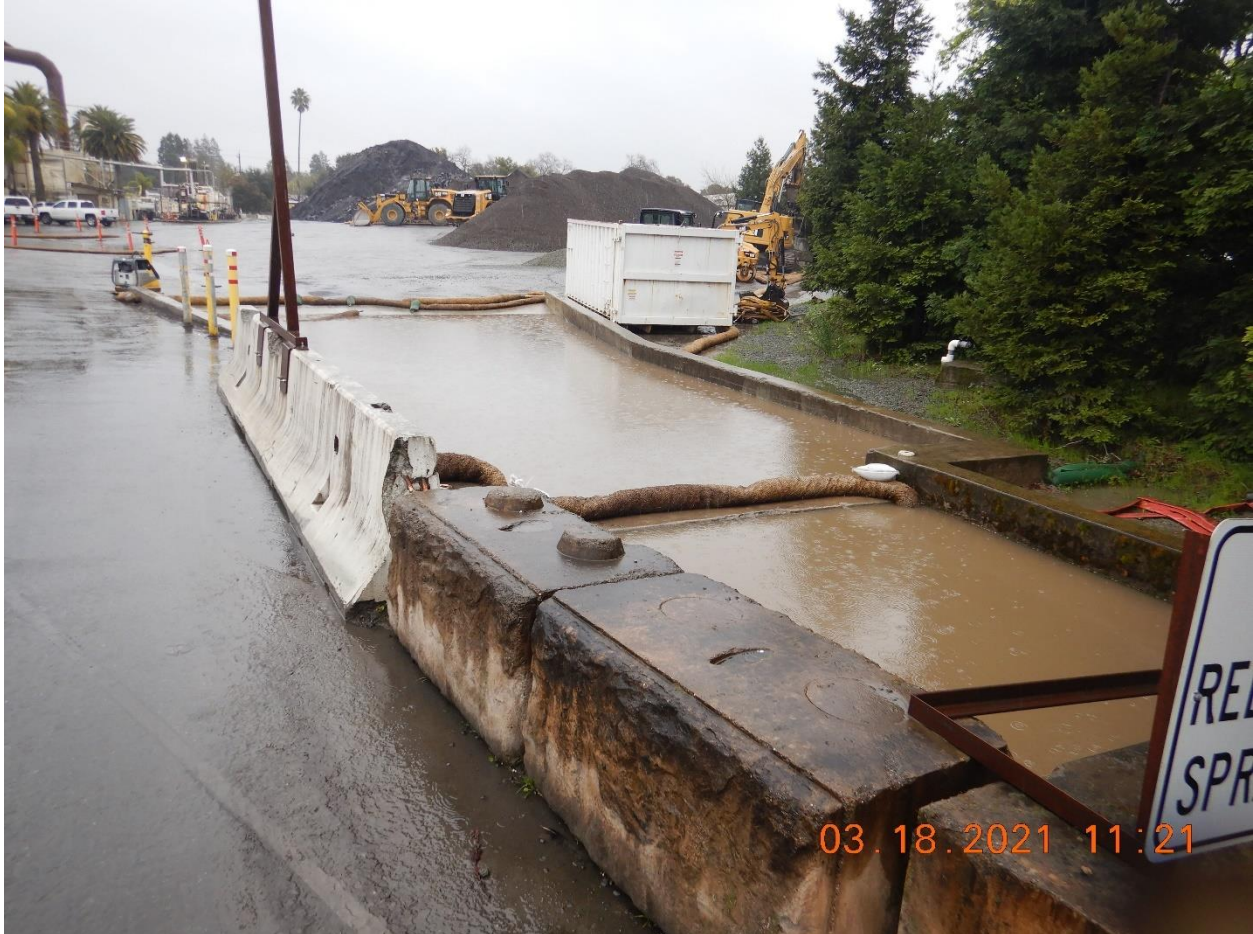
Picture 4- View of an existing settling pond full of turbid water, located on the southwest corner of the facility.

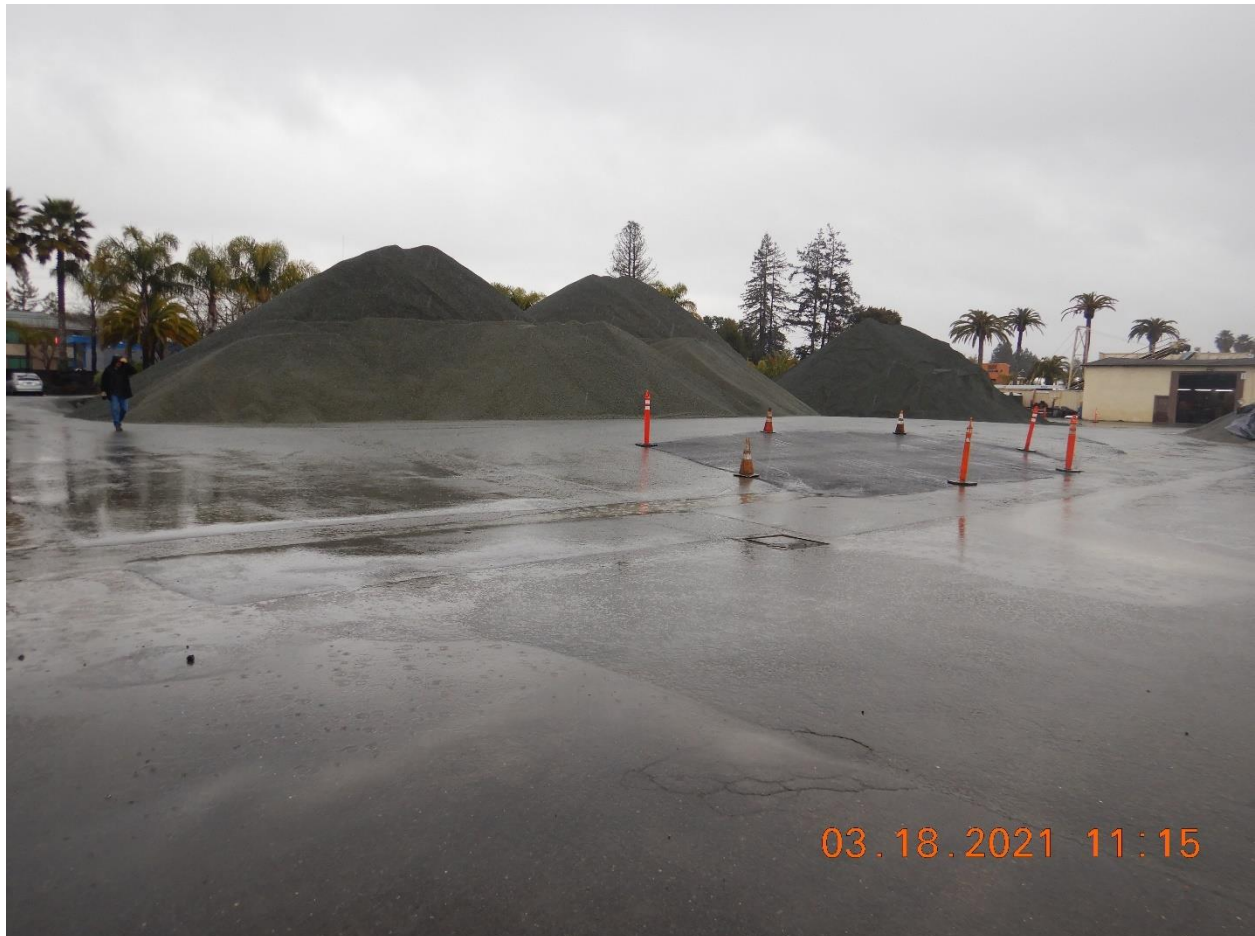
On March 18, 2021 staff again inspected this Facility, this time during a QSE. I walked through the Facility with Josh Leask, Operation Manager, and Masele Poueu, BoDean staff. During this inspection, I observed two asphalt stockpiles that were covered; the remaining numerous aggregate and asphalt waste stockpiles were uncovered (see attached photos 5, 8, 9, 12, and 13). I observed that some of the fiber rolls that had been deployed as sediment control BMPs were saggy and appeared to be old and some had not been appropriately installed (see attached photos 4, 6, and 7). With the exception of two covered asphalt stockpiles, the remaining aggregate and asphalt waste material stockpiles were exposed to rain. I reminded Facility staff that source control needed to be implemented effectively to minimize the high level of sedimentation downstream in the stormwater discharged from the Facility.

Picture 5- View of uncovered stockpiles exposed to rain. Picture taken by Farzad Kasmaei.

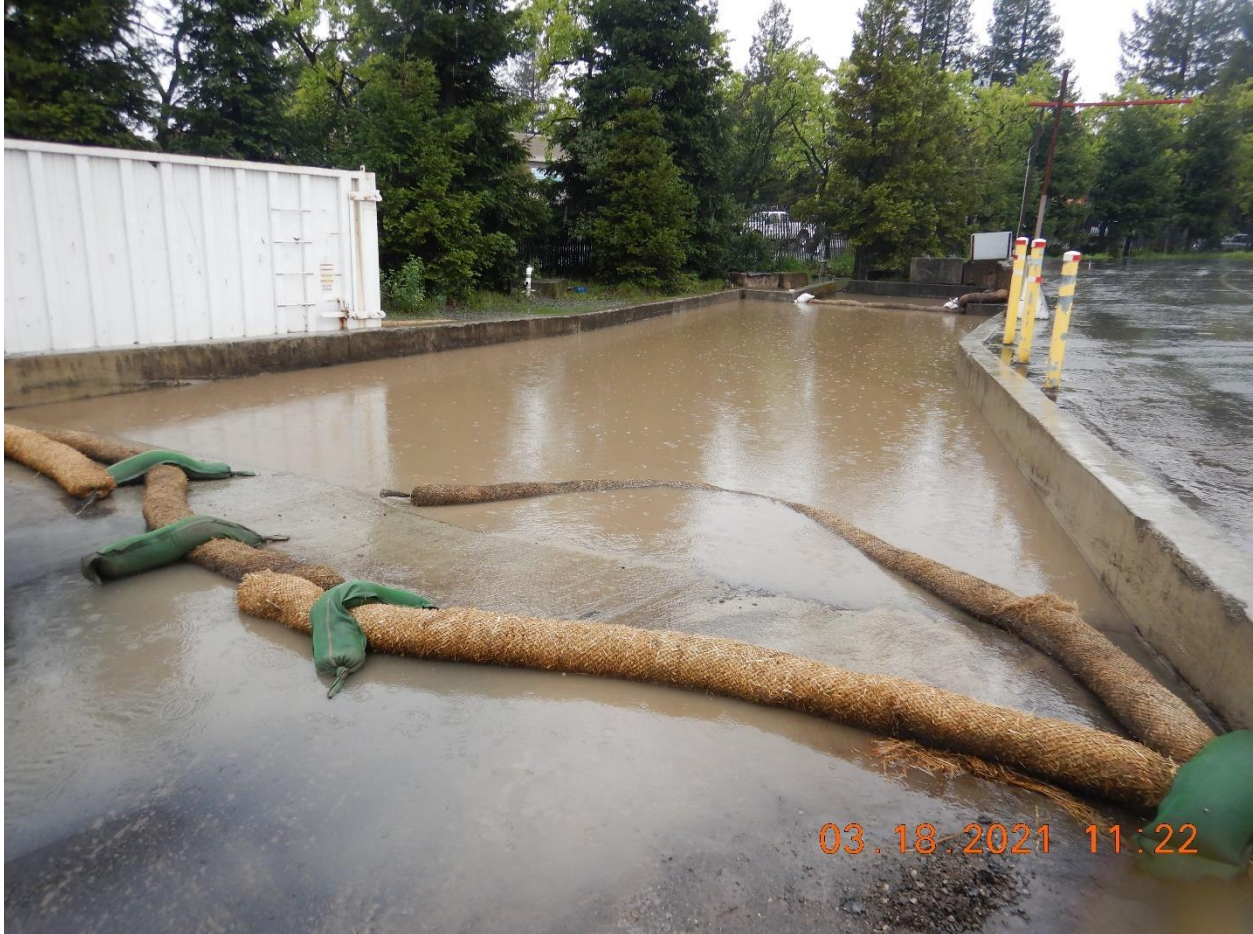
Picture 6- View of installed fiber rolls used as a sediment control BMPs. Some of the fiber rolls need to be maintained and some are not appropriately installed. Picture taken by Farzad Kasmaei.

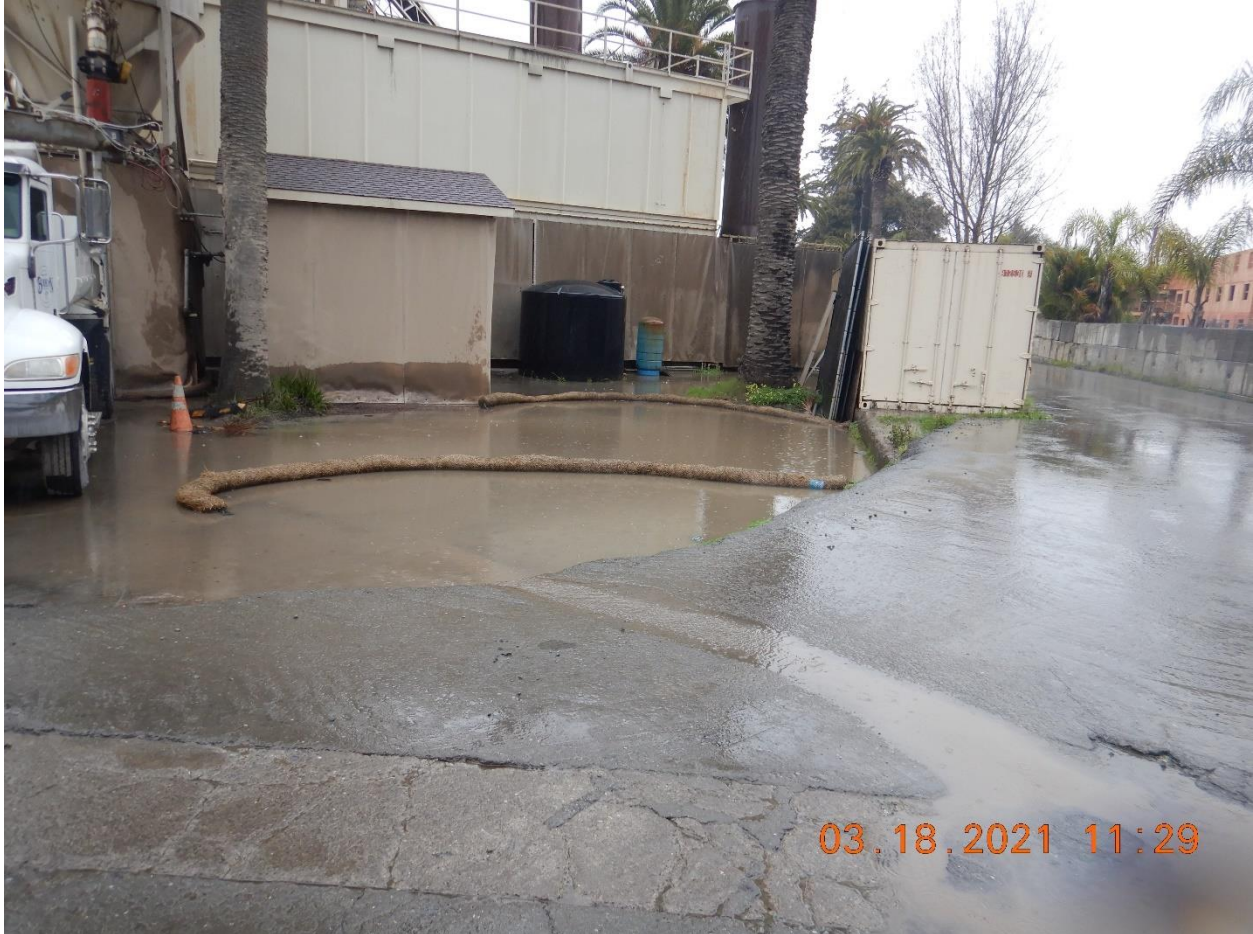
Picture 7- View of a turbid water runoff flow toward the inlet that is not shown in the photo. Picture taken by Farzad Kasmaei.

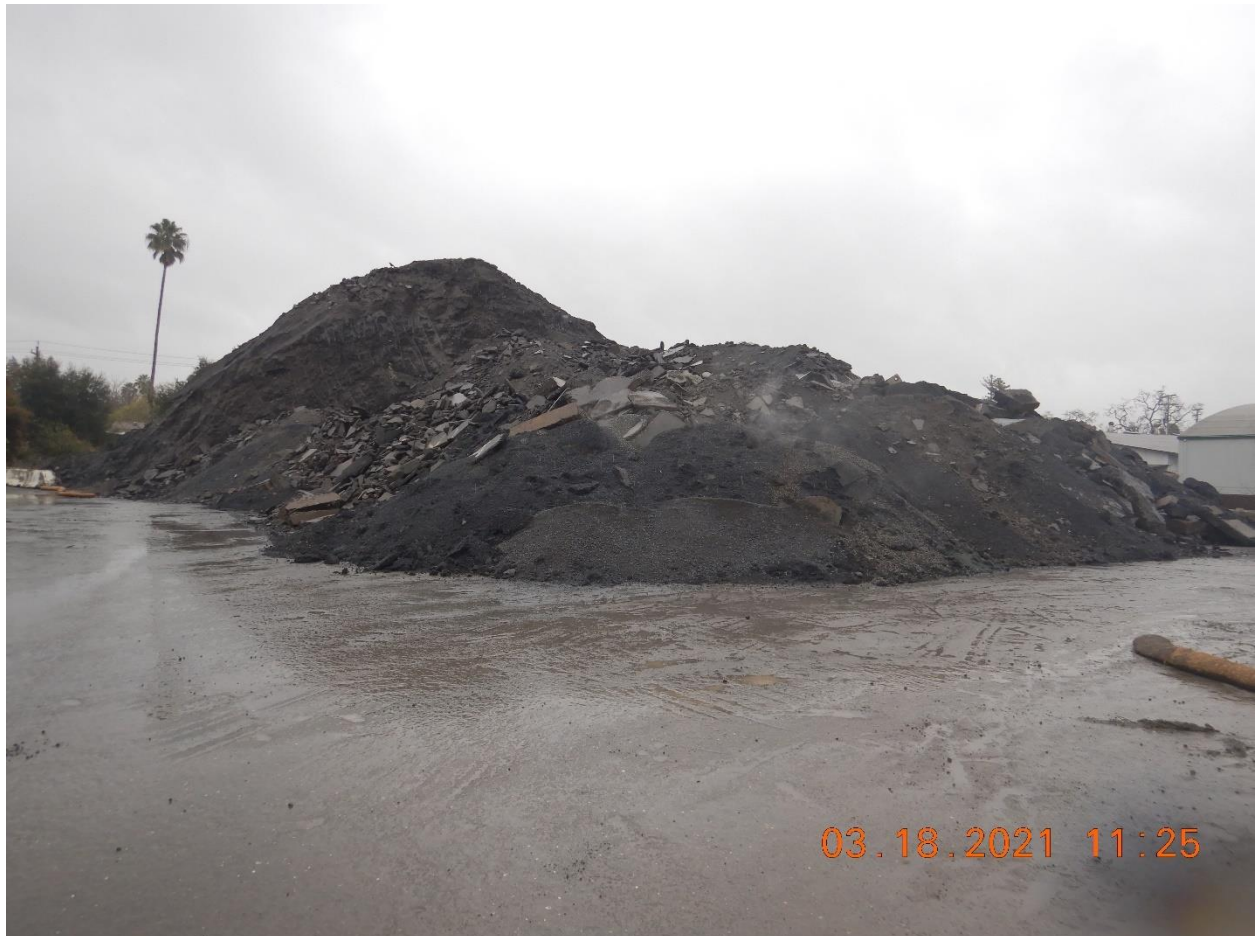
Picture 8- View of the uncovered asphalt waste material stockpile all exposed to rain and lacking perimeter control BMPs. Picture taken by Farzad Kasmaei.

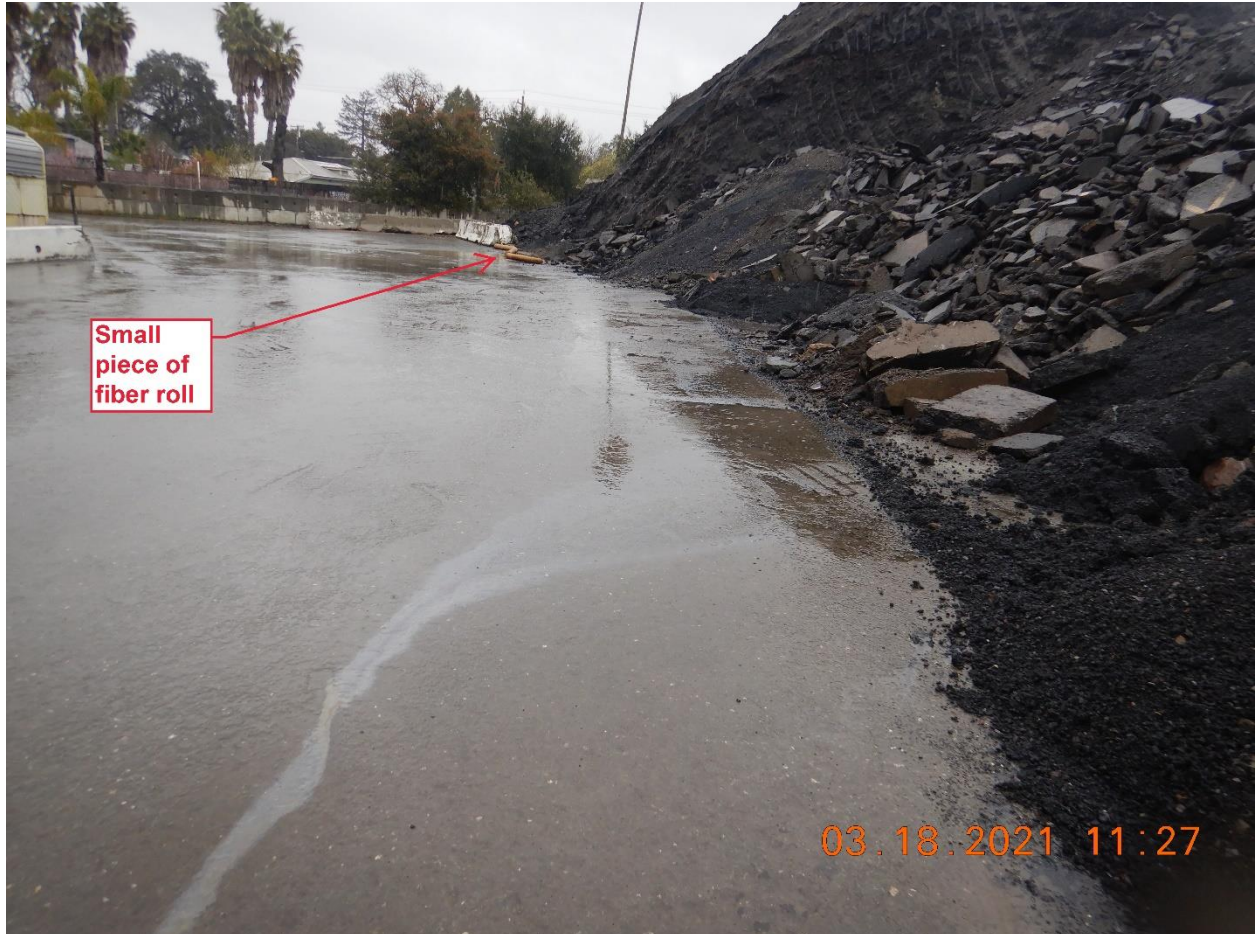
Picture 9 - View of the uncovered asphalt recycling waste stockpile. Only a small piece of fiber roll (shown on the photo close by the white K-rail) has been used as a perimeter control BMP. Obviously, this fiber roll is not installed properly, and it is not adequate for such a large asphalt waste material stockpile. Picture taken by Farzad Kasmaei.

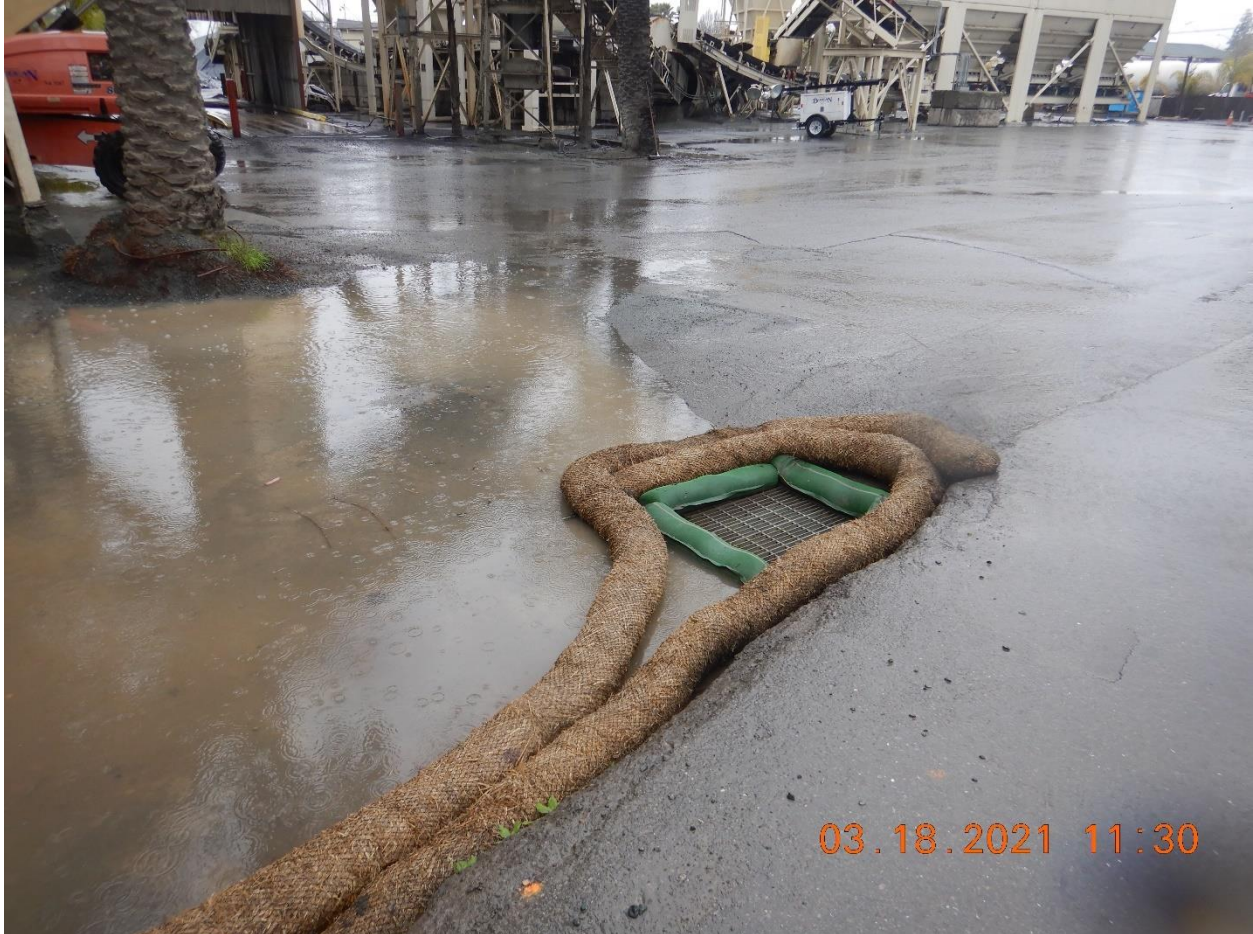
Picture 10 - View of drain inlet protection BMPs. Picture taken by Farzad Kasmaei.

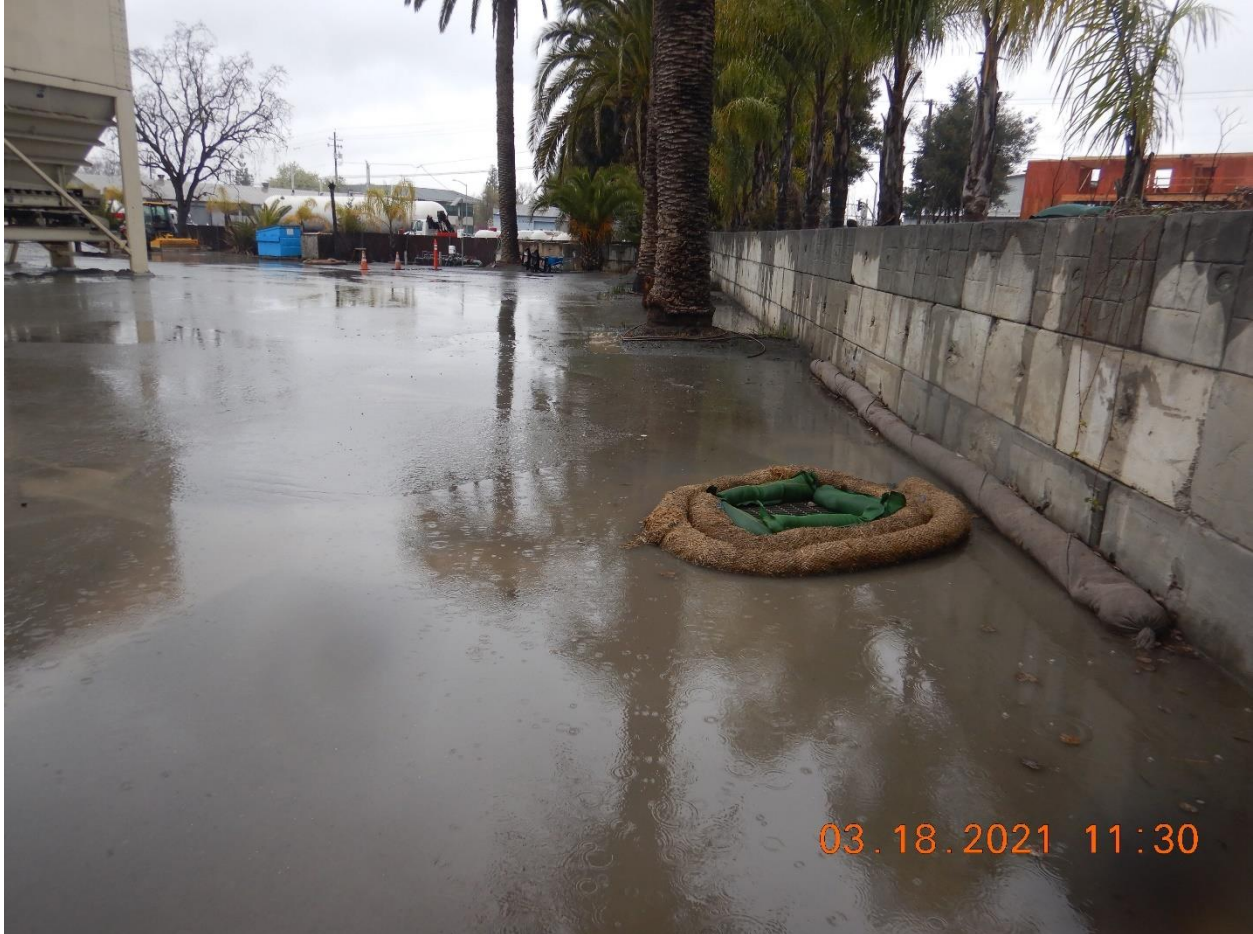
Pictures 11 – View of another drain inlet located on the east side of the facility. Picture taken by Farzad Kasmaei.

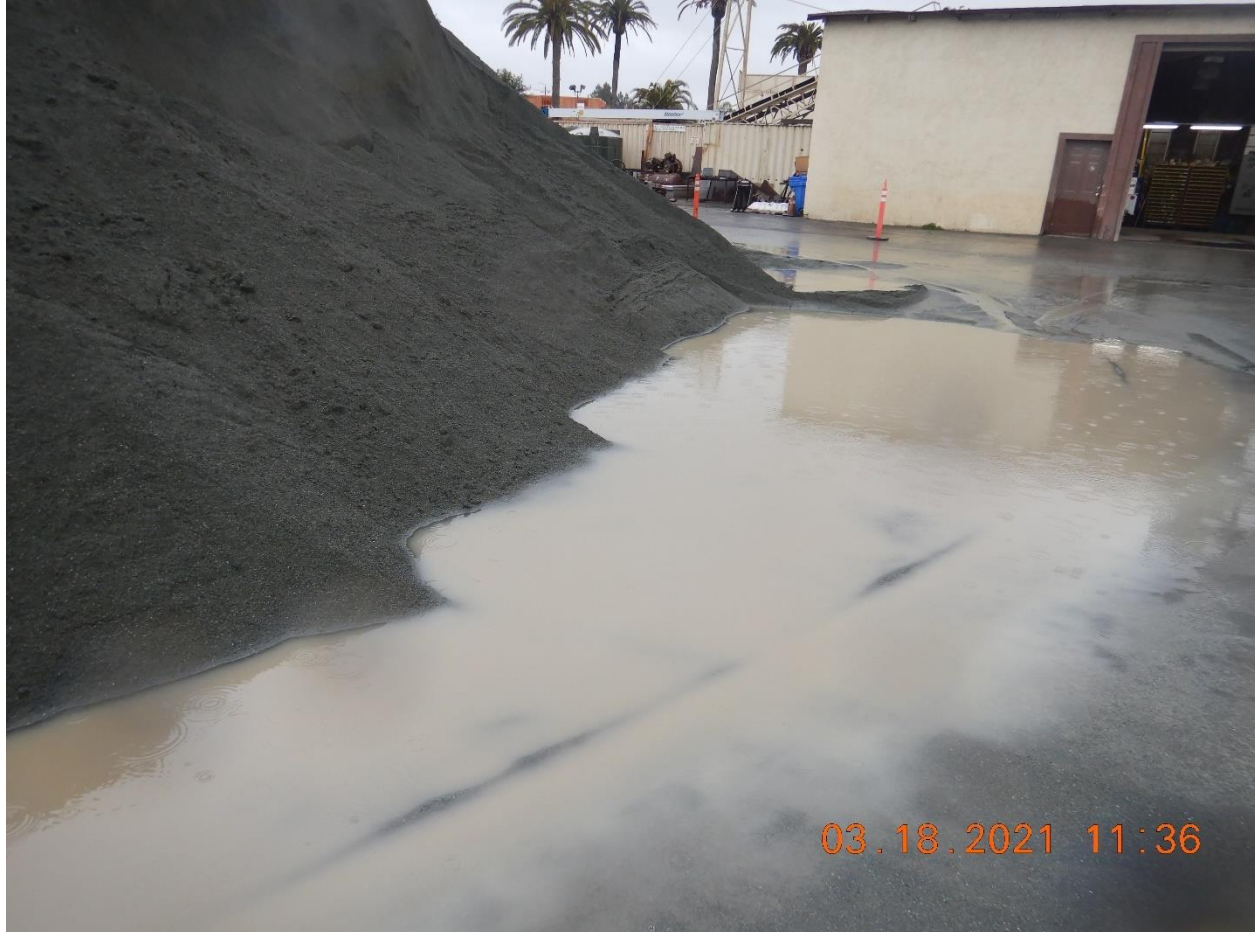
Pictures 12 – View of an uncovered aggregate stockpile lacking perimeter control BMPs and turbid water around it. Picture taken by Farzad Kasmaei

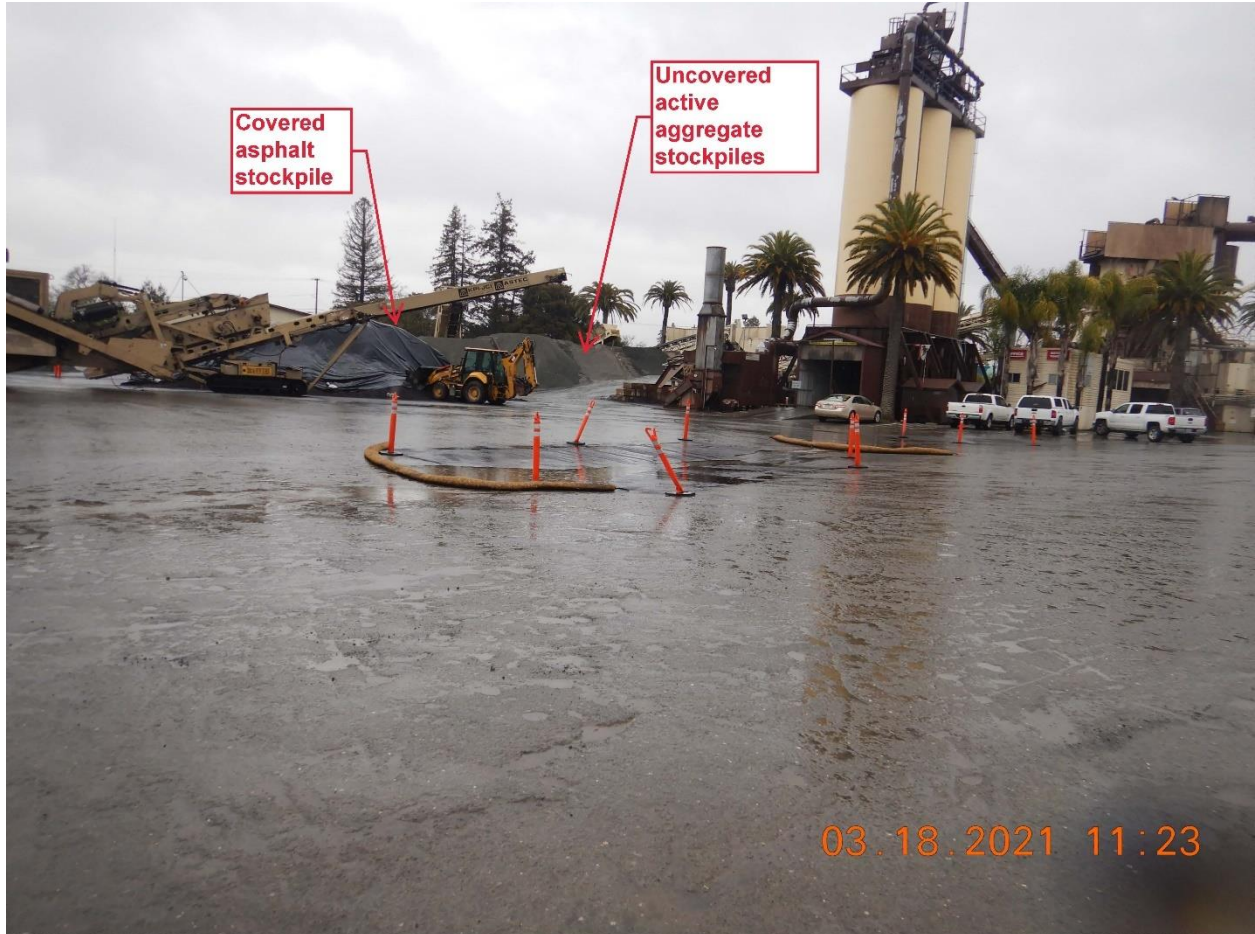
Pictures 13 – View of covered and uncovered stockpiles. Only two asphalt stockpiles were covered, and the rest of the aggregate material stockpiles along with the asphalt recycling stockpiles were uncovered. Picture taken by Farzad Kasmaei

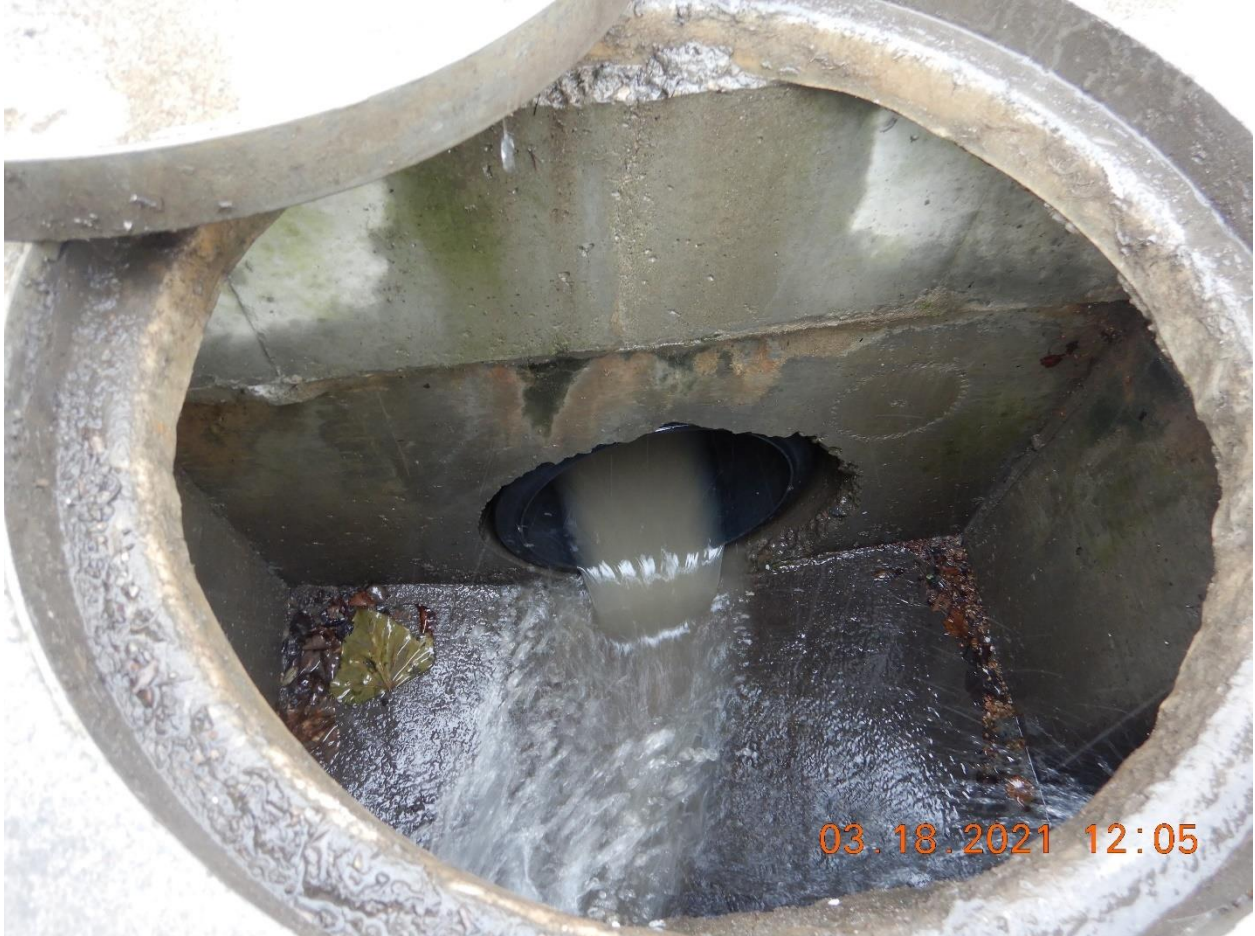
Field measurements showed a turbidity level of 488 NTU, indicating a high level of sedimentation in the facility's runoff (see attached photos 14, 15, and 16), and the pH value of 7.96, which is within the acceptable range. Samples were collected for lab analysis, chain of custody was completed, and the samples were delivered to the FedEx office by me, Farzad Kasmaei, to be transported to Babcock Laboratories the same day.

Pictures 14 – View inside the public storm drain system of the stormwater discharging from the facility. This location is the sampling point for the facility. The entire facility drains to this location and is the only source of the discharge. The discharged water is turbid. (Refer to the attached site map for location)

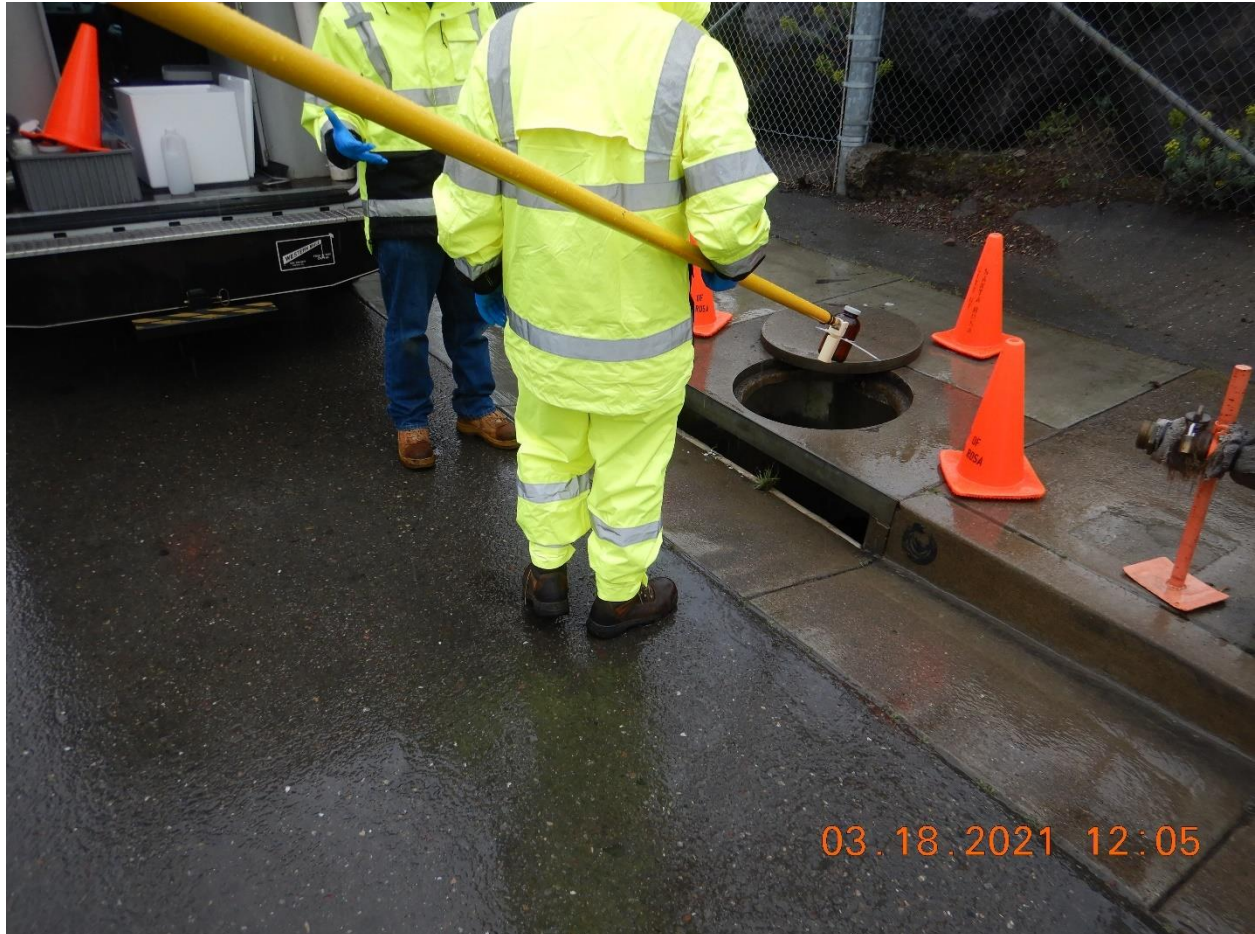
Pictures 15 – View of City of Santa Rosa representatives collecting samples from the discharge point. Picture taken by Farzad Kasmaei.

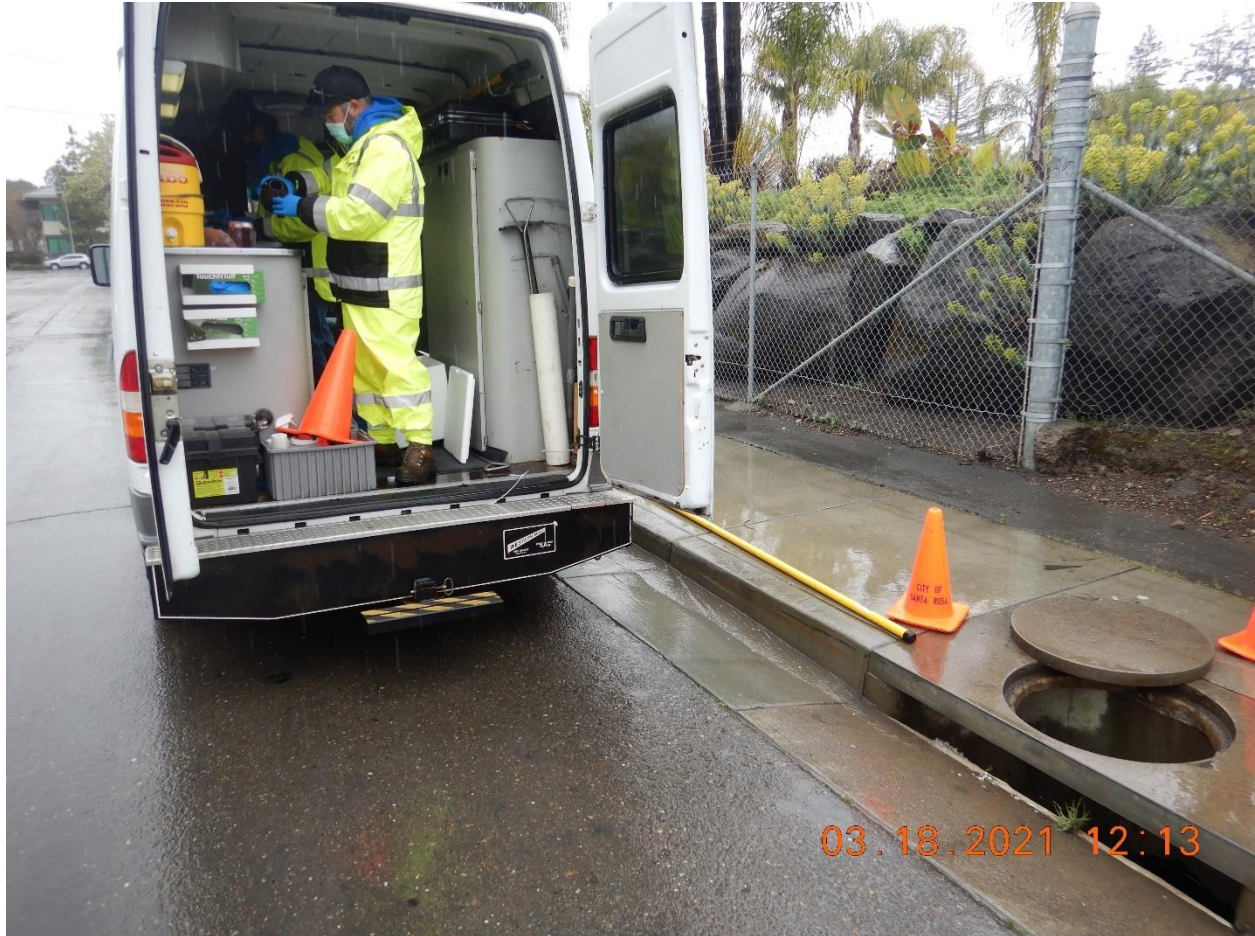
Pictures 16 – View of the sampling point and Santa Rosa representatives performing field measurements for turbidity and pH. Picture taken by Farzad Kasmaei.

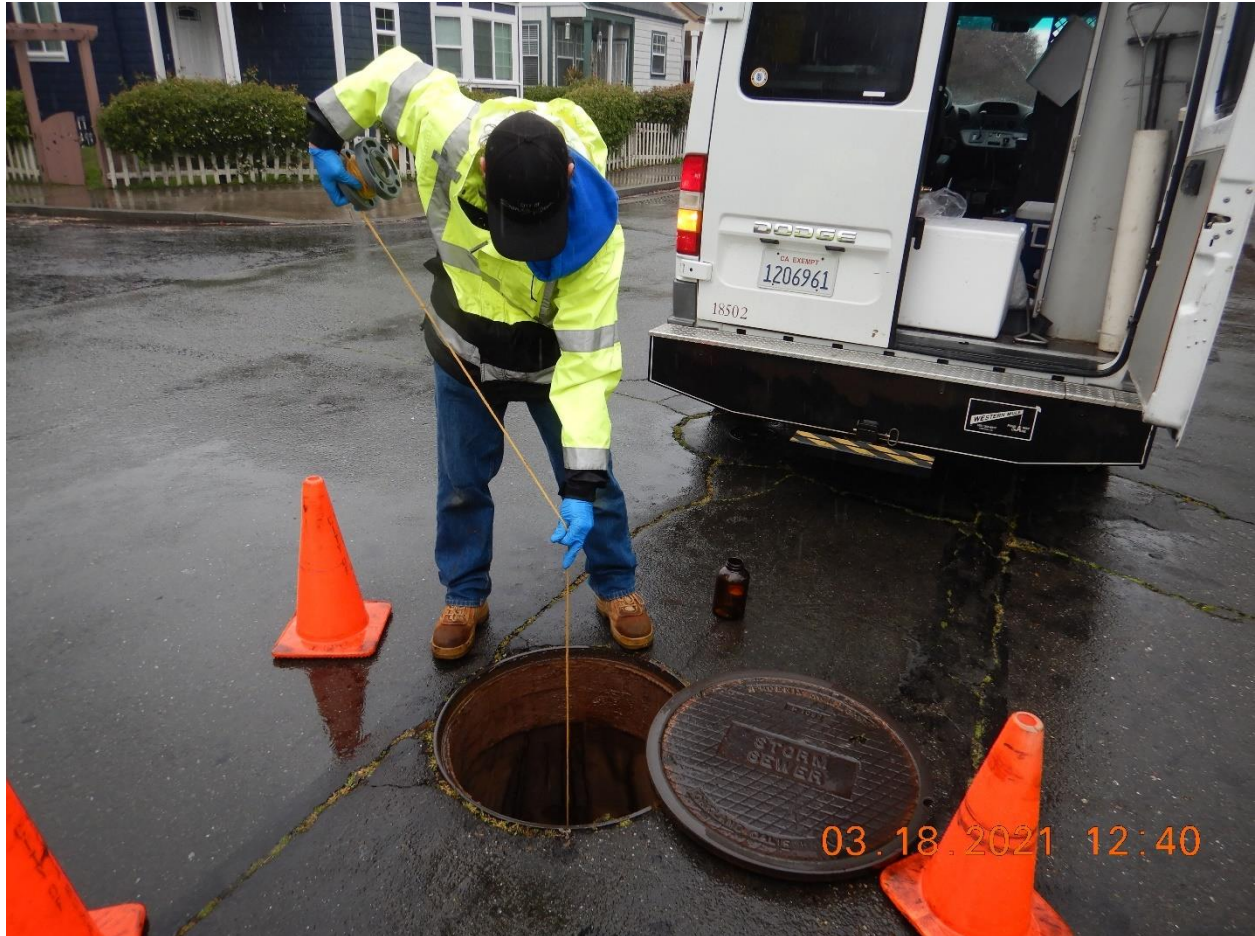
Picture 17 – View of the sampling location off-site to measure the Hardness for receiving water (College Creek). Picture taken by Farzad Kasmaei.

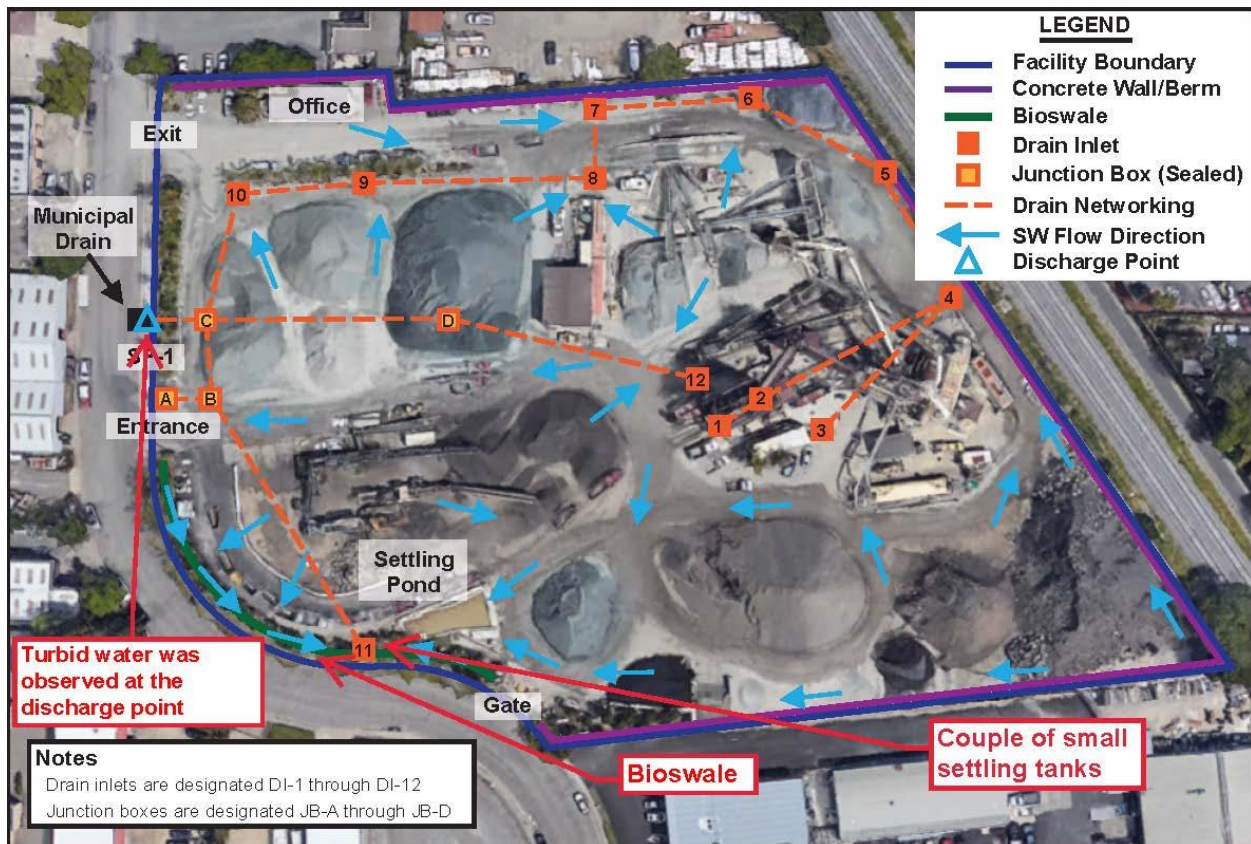
Picture 18 – Site Map showing the locations of the discharge sampling point as well as the existing bioswale and settling pond. Base site map dated November 8, 2017, as submitted by EPS on behalf of Dean Soiland, via SMARTS. Text boxes with arrows added for clarity by Regional Water Board staff Farzad Kasmaei.
